**ENDODONTICS**

**REMOVE FRACTURED ENDODONTIC INSTRUMENTS FROM ROOT CANAL SYSTEMS USING OF  
OPERATING MICROSCOPE**

**Lazar Yessayan<sup>1\*</sup>, Gasparyan Gohar<sup>2</sup>, Sahakyan Bella<sup>2</sup>, Nahapetyan Zaruhi<sup>2</sup>**

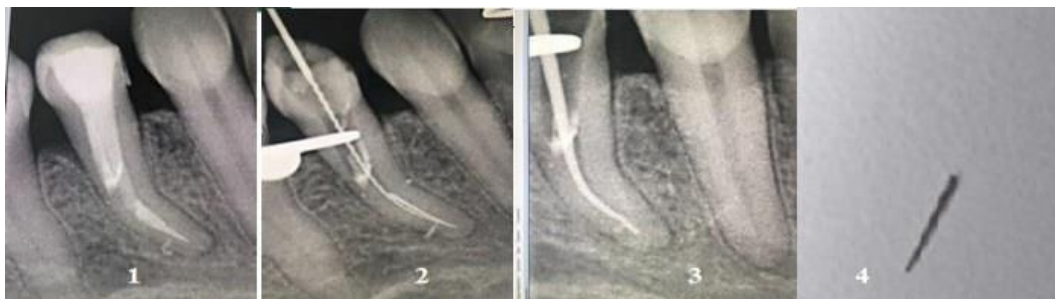
**Figure 1. Rentgen picters fractured endodontic instruments in root canal.**

**Figure 2. Rentgen picters remove fractured endodontic instruments in root canal**

**Figure 3. After removal of the instrument, the tooth canal was filled and the tooth was filled**

**Figure 4. Fractured Endodontic Instruments from Root Canal Systems**

After loosening the broken instrument from the curved canals, it was caught and removed using special pliers with fine toothed branches. After the broken was removed, we proceeded to the next stage removal of the residual cement and paste in the coronal part of the root canal with an ultrasonic tip. The sealant was removed from the mid and apical root canal using Pro Taper D1-D3 endo-denture rotary instruments. After ensuring the patency of the root canals (the second canal was detected palatally), the following procedure followed mechanical and chemical cleaning and the formation of the root canal. Used Crown Down technology and K3 rotary nickel-titanium files. 3% H<sub>2</sub>O<sub>2</sub> and 2.5% sodium hypochlorite were used for short term treatments. A 17% EDTA solution was used to the tooth was filled (fig.1-4).
